ATTLEBORO PUBLIC LIBRARY

BUILDING ENVELOPE REPAIR & MECHANICAL SYSTEM UPGRADE

Attleboro, MA

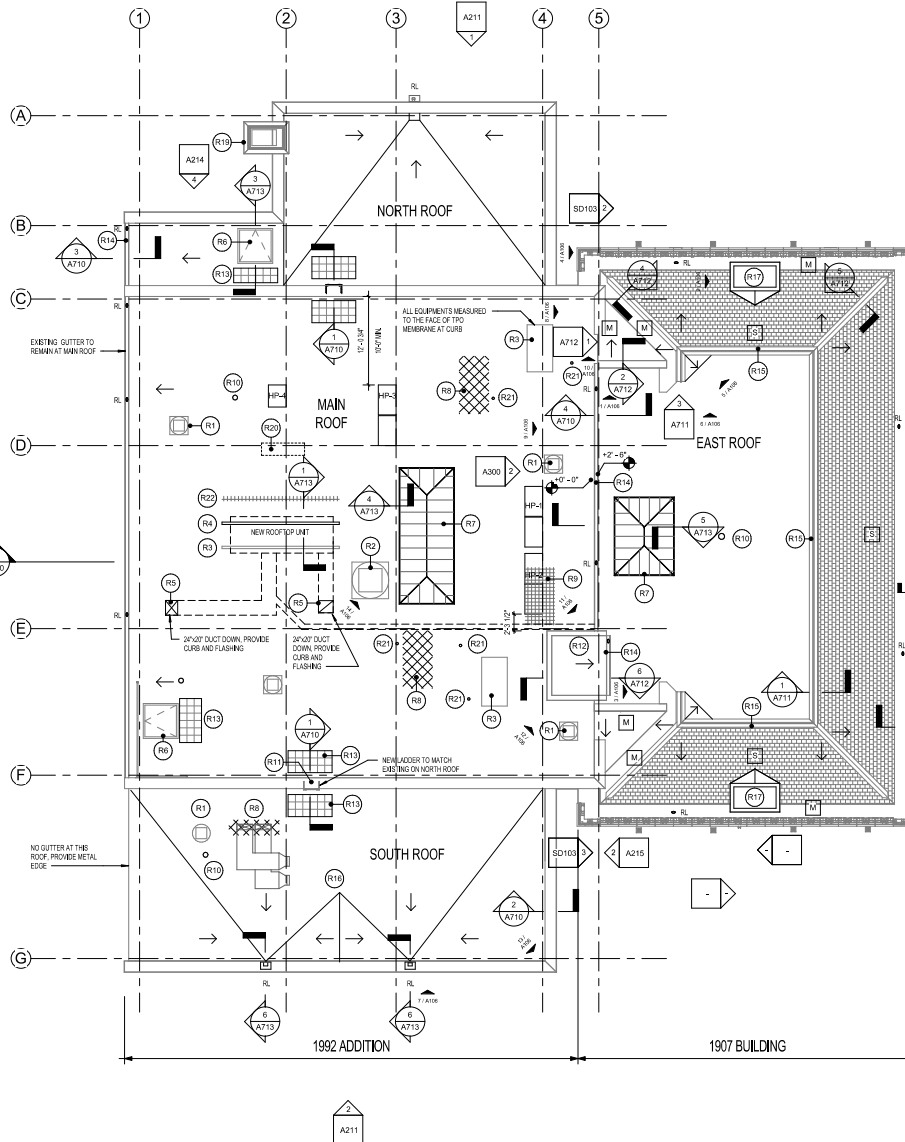
2 ROOF PLAN
1/8" = 1'-0"

- R1 EXISTING FAN WITH FLASHINGS AT CURBS TO REMAIN.
- R2 EXISTING SMOKE EVACUATION VENT WITH FLASHINGS AT CURBS TO REMAIN.
- R3 EXISTING CURBS FOR MECHANICAL EQUIPMENT TO REMAIN. THEY GET NEW EQUIPMENT IN SAME LOCATION. PROVIDE REPAIRS AT FLASHINGS. EQUIPMENT WILL REMOVE EXISTING OPENINGS IN ROOF. BOX SHOWS GENERAL OUTLINE OF EXISTING CURBS.

- R9 LOCATION OF EXISTING MECHANICAL EQUIPMENT TO BE REMOVED. THIS LOCATION HAS NO EXISTING OPENING FOR DUCTS THROUGH ROOF. REPAIR ROOFING AT CURB WHERE EQUIPMENT IS REMOVED BY ADDING NEW INSULATION OVER EXISTING METAL DECK.

101. SOME EXISTING ROOF MATERIALS AND ELEMENTS ARE TO REMAIN. PROTECT ALL ITEMS TO REMAIN. CONTRACTOR IS RESPONSIBLE FOR ANY DAMAGE DUE TO CONSTRUCTION ACTIVITY AND LACK OF PROTECTION.

104. SEE PHASING PLAN FOR REQUIREMENTS RELATIVE TO OTHER WORK.

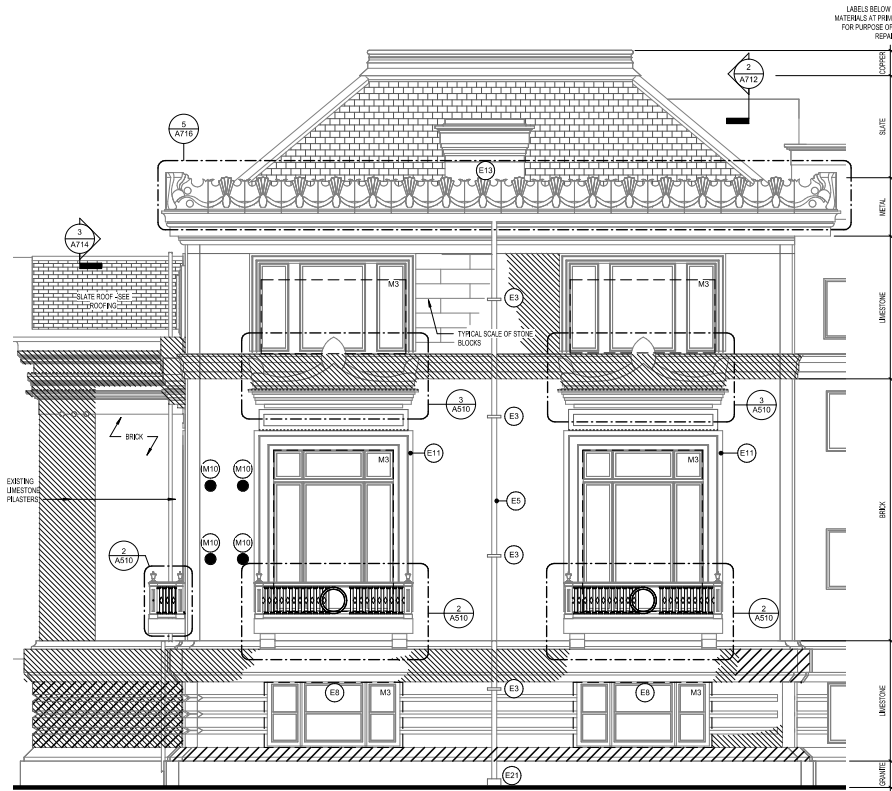
1 Enlarged North Elevation (1907)
1/4" = 1'-0"

LABELS BELOW IDENTIFY EXISTING MATERIALS AT PRIMARY BUILDING FACADE. FOR PURPOSE OF CLIPPING AREA OF REPAIR SCOPE

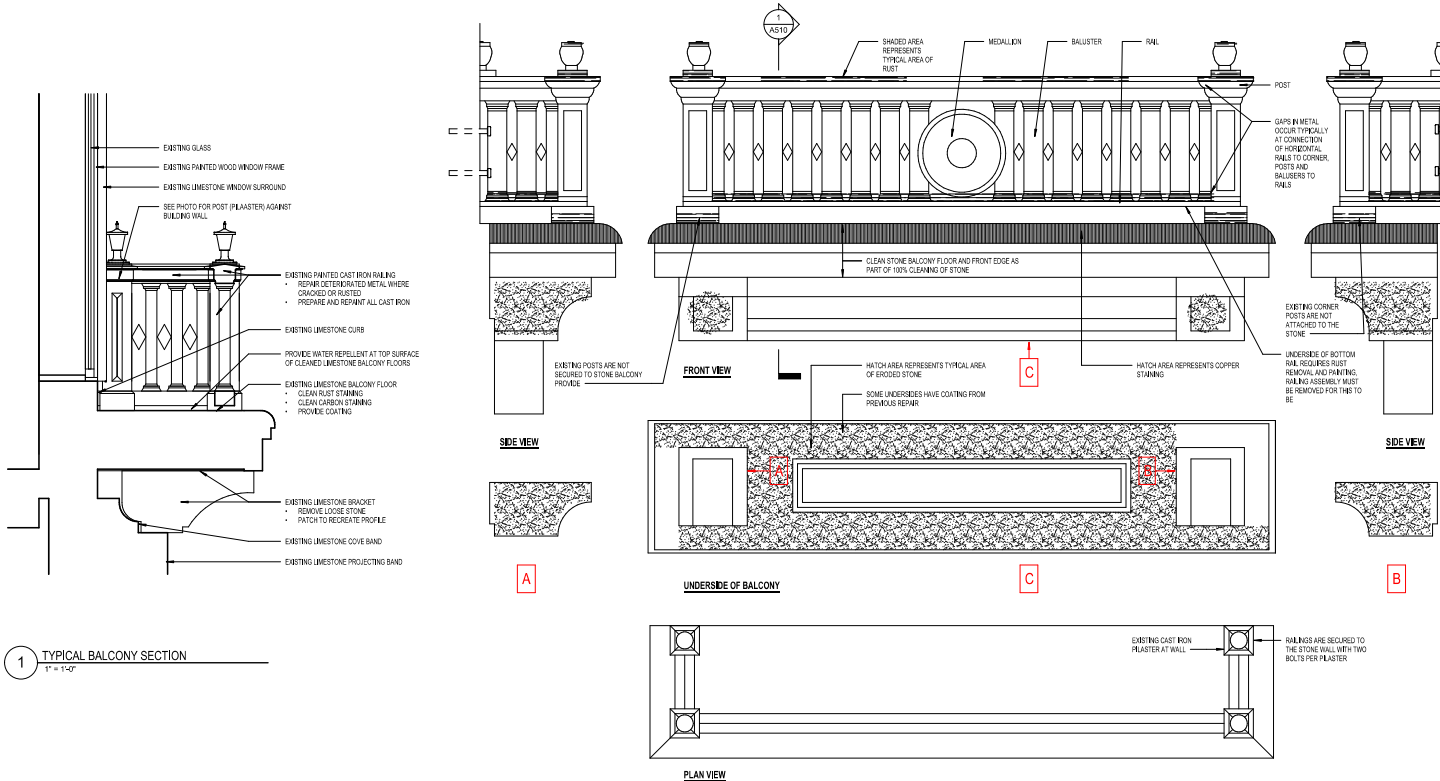
EXISTING RAILING SYSTEM AND ANCHORS TO BE REMOVED AND REPLACED WITH STAINLESS STEEL AND ANCHORS OF SAME DIAMETER. CONDITION OF EXISTING WALL SUBSTRATE IS TO BE EVALUATED FOLLOWING REMOVAL OF EXISTING ANCHORS. ONCE STRUCTURAL INTEGRITY OF EXISTING WALL AT ANCHORAGE LOCATIONS IS VERIFIED, NEW ANCHORS ARE TO BE EMBEDDED INTO EXISTING BEARING WALL WITH HILTI HIT RE 309 VS IN ACCORDANCE WITH ANCHORING. OR APPROVED EQUAL CONTRACTOR TO PROVIDE STRUCTURAL ENGINEER WITH HILTI DIAMETER AND SPACING SUCH THAT REQUIRED EMBEDMENT MAY BE DETERMINED AND ANCHORAGE LOAD CAPACITY MAY BE VERIFIED TO BE ADEQUATE, TYPICAL.

FOR FINISH, ASSUME 1/2" DIAMETER X 12" LONG STAINLESS STEEL ANCHORS WITH 12" MIN EMBEDMENT.

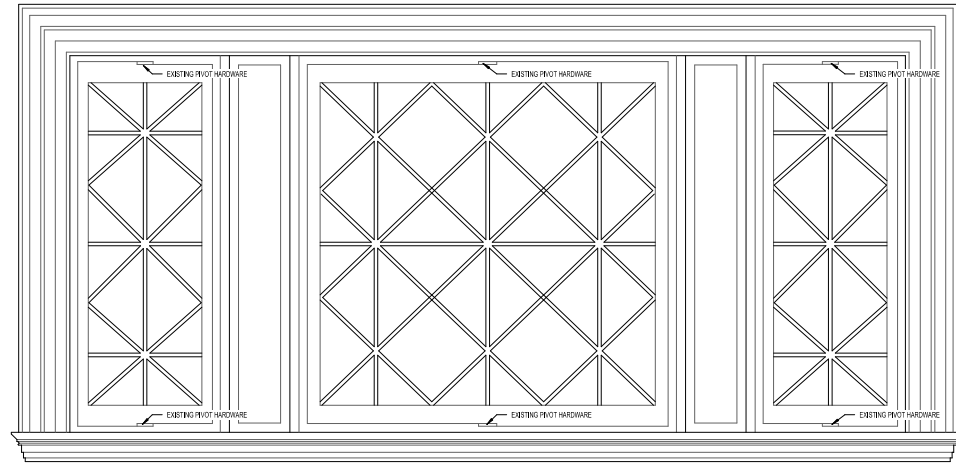
1 TYPE Q INTERIOR ELEVATION
1 1/2" = 1'-0"

- STRIP ALL EXTERIOR PAINT AND PAINT SASHFRAME EDGES WHERE SASHFRAME CLOSURES.
- REMOVE CALK FROM WOODSASH JOINT.
- REMOVE GLAZING PUTTY. (NOTE: WINDOW TYPE Q DO NOT APPEAR TO HAVE GLAZING PUTTY).
- REPAIR DETERIORATED WOOD AT SILL, BOTTOMS OF BRICKMOLDS, BOTTOMS OF SASH (RAIL & STILES) W/ EPOXY PRODUCTS.
- PROVIDE GLAZING PUTTY.
- PRIME & PAINT.
- CALK PERIMETER W/WELET JOINT.
- PROTECT EXTERIOR STONE FROM DAMAGE OR PAINT SPATTER.

- STRIP PAINT FROM INTERIOR OF SASH. STRIPPING NOT REQUIRED AT FRAME, STOOL, APRON OR CASING.
- REMOVE EXISTING STORM PANELS AND STORM PANEL HARDWARE. REMOVE ANY HOOK + EYE OR OTHER LATCH HARDWARE. THE ONLY HARDWARE TO REMAIN IS THE PIVOT HARDWARE/METAL WEATHERSTRIPPING AND METAL DRIP EDGE.
- FILL ALL HOLES WHERE HARDWARE IS REMOVED.
- REPAIR WOOD. (NOTE: EPOXY REPAIR AT WOOD WINDOWS IS EXPECTED TO BE LIMITED TO EXTERIOR FACES).
- FILL WINDOWS SHUT WITH REBUILT WALLS.
- PRIME AND PAINT SASH PREP AND PAINT ALL OTHER INTERIOR ELEMENTS OF WINDOWS.
- PROTECT STORM PANELS.
- PROTECT WALLS AND OTHER MATERIALS.

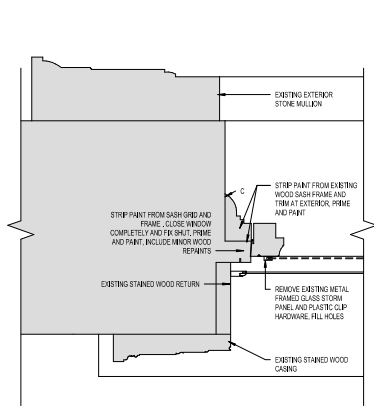
3 PLAN DETAIL AT JAMB,
WINDOW TYPE N
3' = 1'-0"

- WINDOW SCOPE IS THE SAME AS TYPE Q WITH THE FOLLOWING EXCEPTIONS
- INTERIOR WOODWORK IS STAINED RATHER THAN PAINTED, AND MATCHES OTHER WOODWORK IN THE ROOM. RE-STAINING IS LIMITED TO INTERIOR SASH AND STOOLS. DO NOT STRIP STAIN AT SASH AND STOOL. SCOPE IS TO INFILL WORK AREAS.
- EXTENDERS OF THIS WINDOW DO HAVE GLAZING PUTTY, REMOVE EXISTING, PROVIDE NEW GLAZING PUTTY TO BE PAINTED BY PAINTER.
